# BEACH STABILIZATION TESTS OF LANDING MATS AND PREFABRICATED MEMBRANES

TECHNICAL REPORT NO. 3-592

February 1962

U. S. Army Engineer Waterways Experiment Station  
CORPS OF ENGINEERS  
Vicksburg, Mississippi

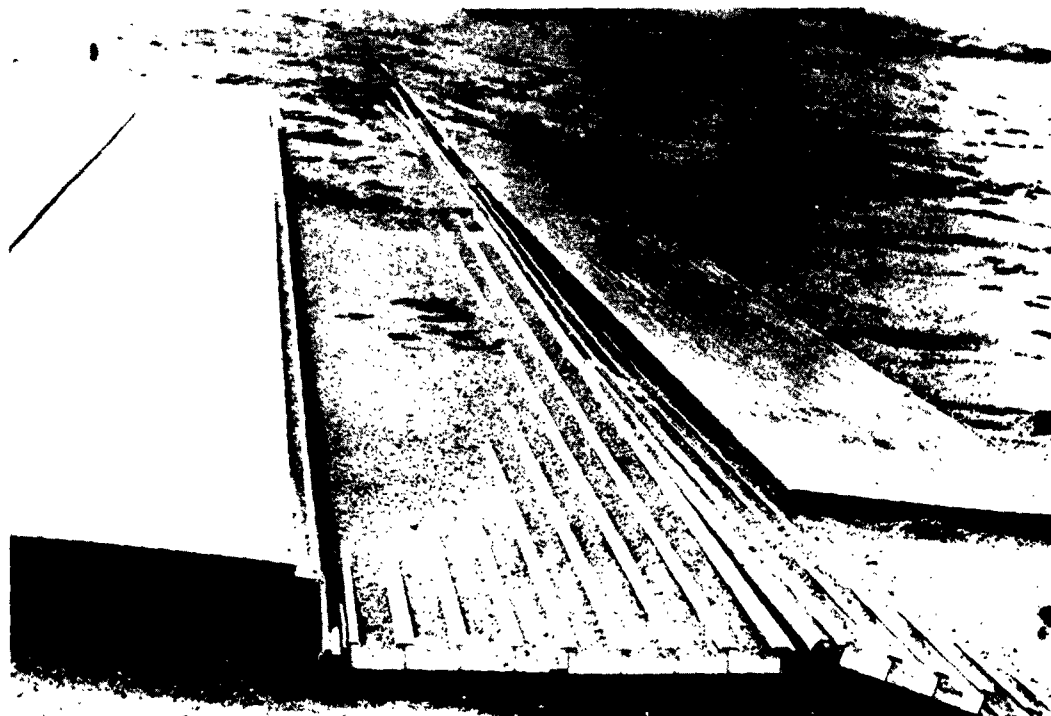
21. On the morning of 23 May (after 404 passes), it was observed that the outer seven runs of panels had become disengaged from the other mats during the night. Three of the runs were partially buried in the sand at the lower end of the test lane, and two of these had flipped over as shown in photograph 2. The other four runs of panels were found at low tide scattered over an area about 40 to 60 ft from the offshore end of the lane and partially buried in the sand. In addition to the displacement of these mats, considerable other damage was also noted at this time. A number of the drive rivets which had been inserted in the end joints after 14 passes of traffic had sheared in the offshore portion of the lane, and about 12 end joints between sta 0+90 and 1+20 had separated as much as a foot. Sand had also been scoured under these separated end joints for a depth of 8 to 10 in. (see photograph 3). All of the test lane below about sta 0+60 was sloping from north to south (see plate 4) as sand had been displaced under the south edge of the lane and deposited under the north edge. Along the south edge of the lane near sta 0+65, sand was scoured to a depth of about 2 ft (photograph 4). The general condition of the tracking lane at this time is shown in photograph 5.

Photograph 2. Overturned panels at offshore end of lane 1, La Turballe,  
404 passes

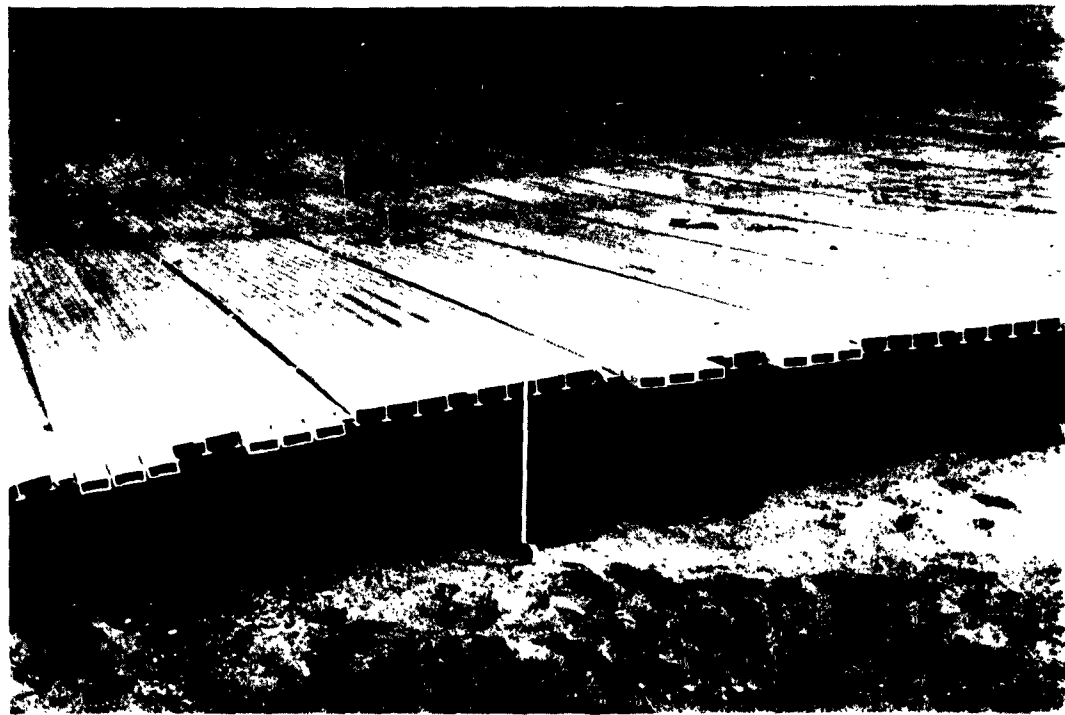
Photograph 4. Scour along south edge of lane 1, La Turballe, 404 passes

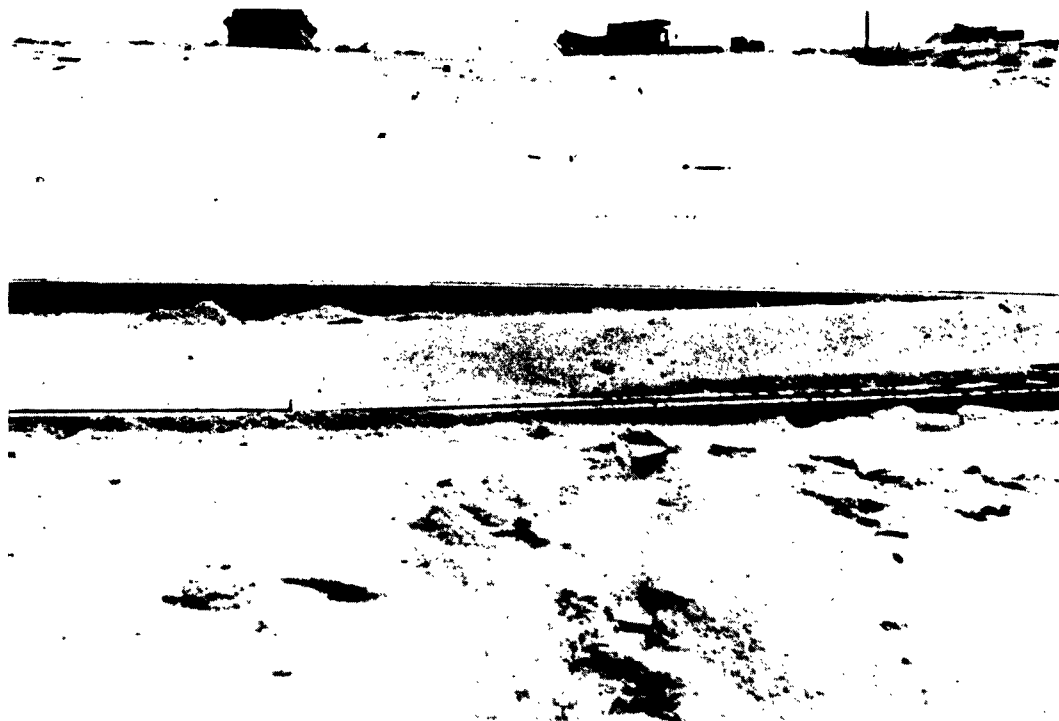
23. During the remainder of the trafficking period, which ended on 26 May after a total of 1000 passes, the extent of separation increased at partially open end joints, although there was no noticeable increase in the number of joints so affected; also one additional run of mat had worked loose at the offshore end of the lane. Photograph 7 shows the general condition of the lane at completion of 1000 passes. Overall, the lane was in poor condition, although it was not considered failed, and traffic could have continued longer by avoiding the separated end joints. Erosion along each edge of the foreshore portion of the lane extended under the mat for 6 to 8 ft; however, in general, the mat in the center portion was in contact with the beach throughout the lane as there had been little erosion in this center area except where the end joints were separated. End joints on the backshore portion of the lane did not separate at any time during traffic, and the mat in this area was relatively undamaged with a smooth surface appearance. Examination of plate 7 shows uniform settlement of most of the mat, either from embedment of the mat or compaction of the subgrade or a combination of both.

Photograph 7. General view of lane 1, La Turballe, 1000 passes

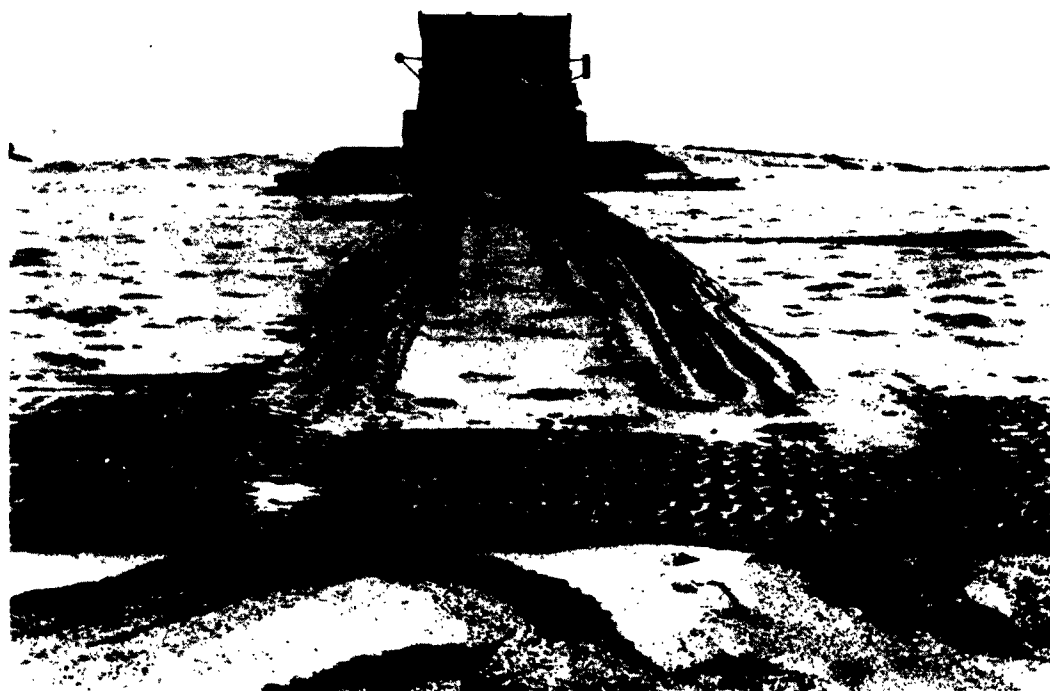
Photograph 10. Deposition of sand on lane 2, La Turballe, 600 passes

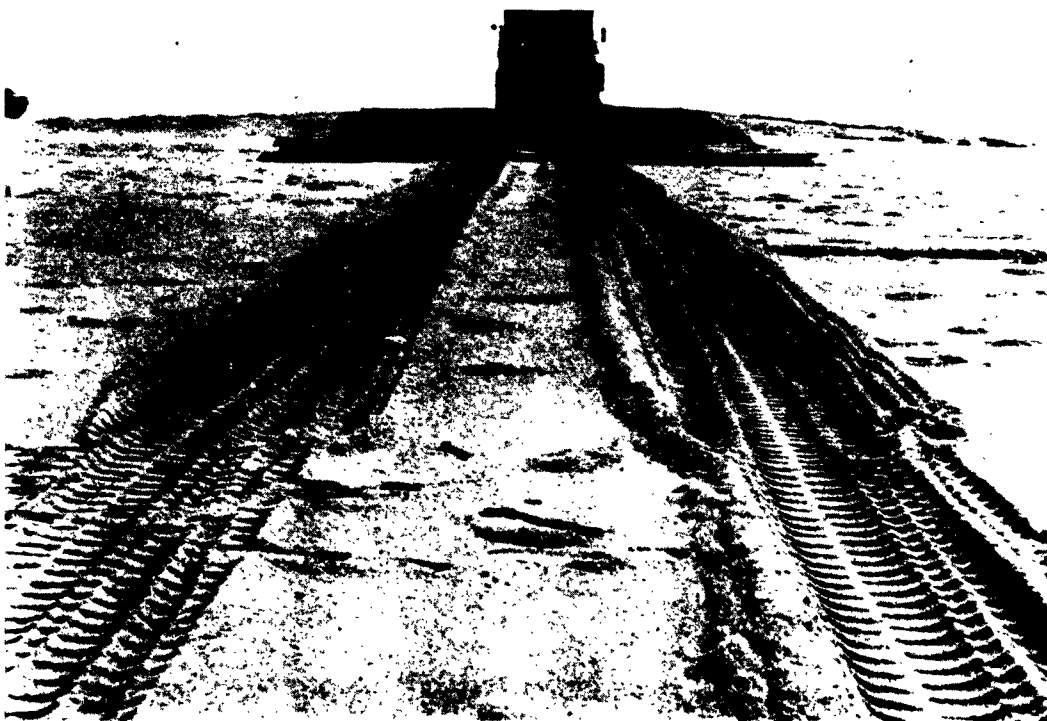
26. At the conclusion of 1000 passes on 25 May, lane 2 was in poor condition but it was not considered failed and traffic could have continued. Photograph 12 shows the general condition of the lane at the end of the test. The surface was much rougher than lane 1, primarily because of areas where the end joints had buckled or the mat had rolled up, but there were no holes in the mat surface in lane 2 as had developed on lane 1 where the end joints separated. Examination of plate 8 shows generally uniform settlement of the mat on the backshore, whereas considerable sand had deposited on the lower portion of the lane (between sta 1+00 and 1+55). The sharp rise shown in plate 8 at about sta 0+95 is at the point of extreme mat buckling described in paragraph 25.

Photograph 12. General view of lane 2, La Turballe, 1000 passes

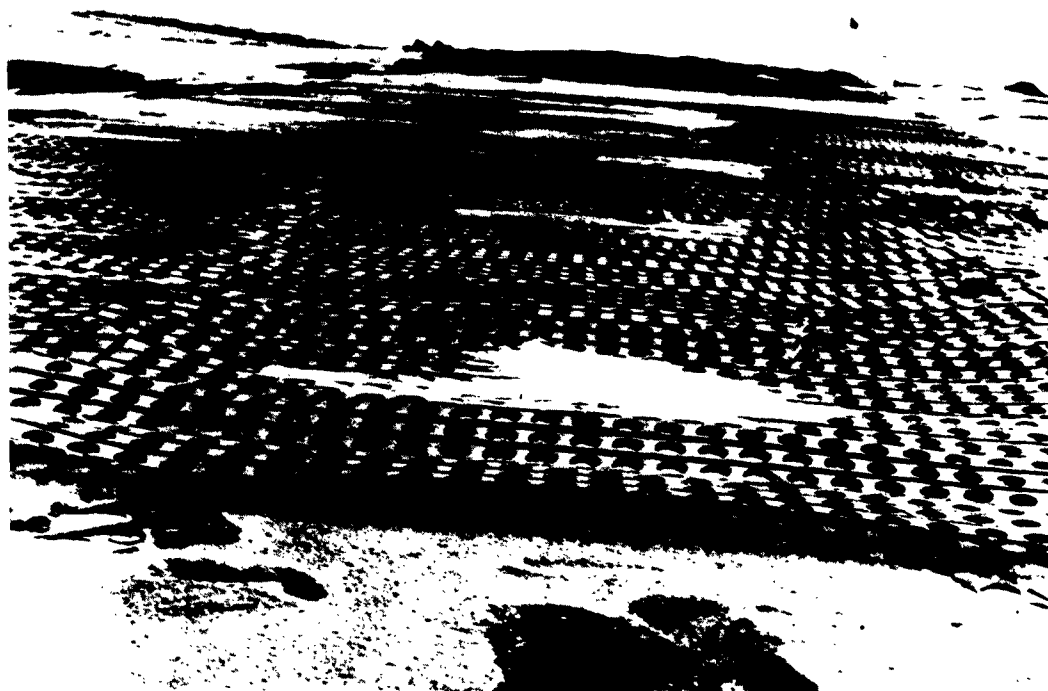
Photograph 16. General view of lane 3, La Turballe, 450 passes

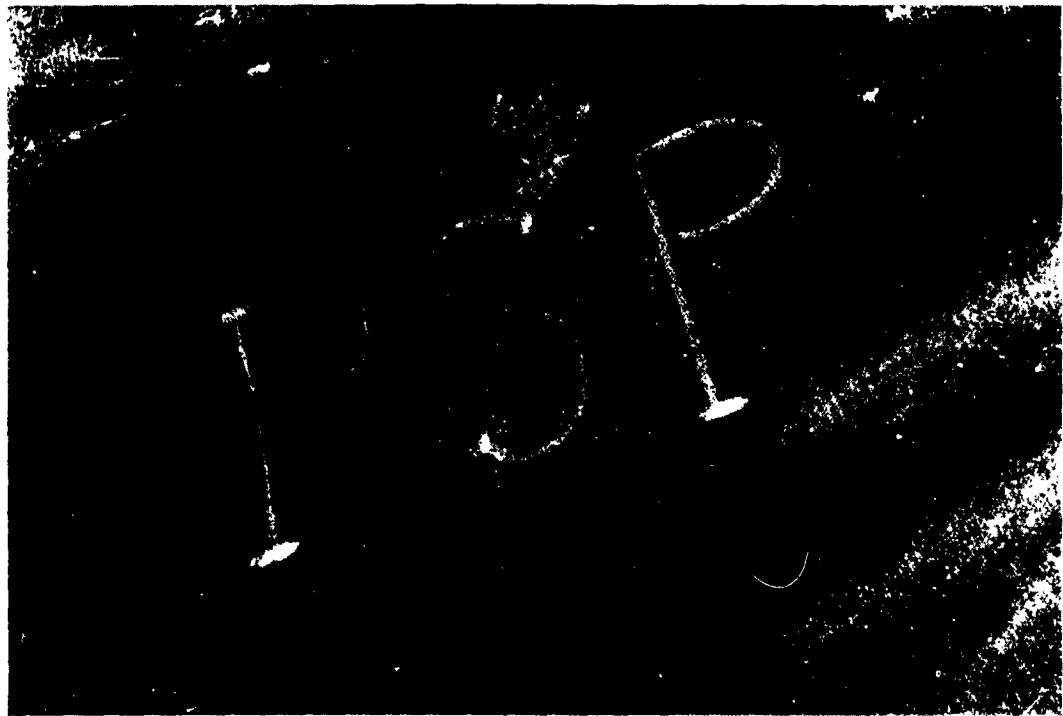
28. The mat was removed from the lane on 27 May 1959, and the membranes were inspected for possible damage. The T14 membrane was not damaged by the overlaid PSP mat, and there were no indications of puncture by the bayonet side connectors (photograph 18). The T1 membrane was not torn, but the bayonet side connectors had punctured the material at several locations (photograph 19). These punctures were not severe as the membrane did not fail completely nor was the subgrade eroded beneath the membrane. Examination of plate 9 shows that little change occurred in the elevation of the inshore portion of the lane, but that considerable sand had been deposited on the offshore portion.

Photograph 18. T14 nylon membrane on lane 3, La Turballe, 1000 passes

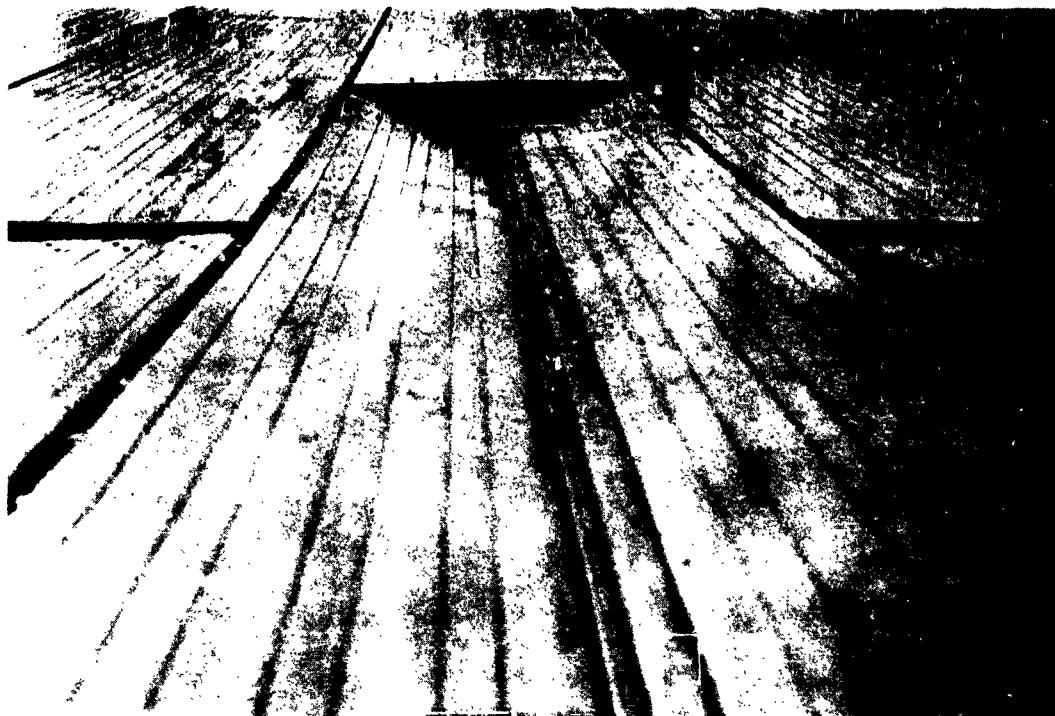
Photograph 25, Failure of splice-joint rivets in T11 mat, lane 1, Suscinio, 200 passes
